Flat 2, 30 Walpole Road, Bournemouth,  
England, BH1 4HD

## This report contains

Property presented in very good order and has been newly renovated pretty much throughout.

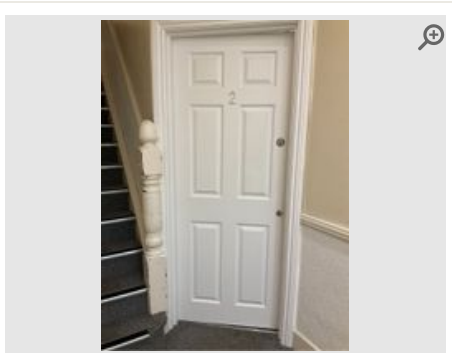
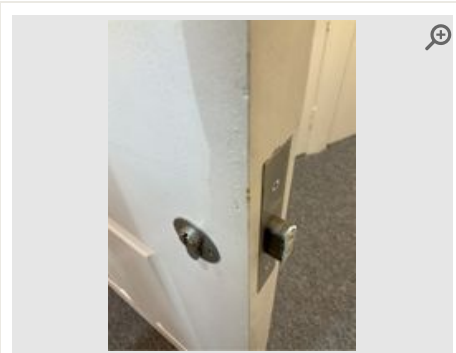
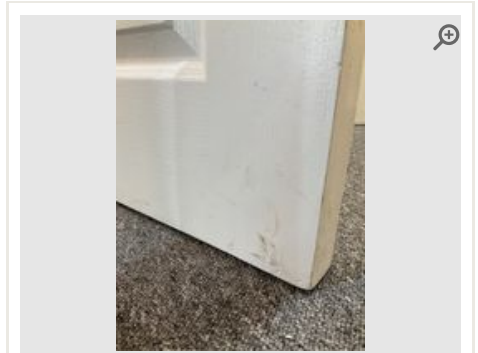
Front Door

1.2 <b>Front Door</b>	<b>White painted wooden panelled door with chrome effect number 2 and 2X stainless steel Yale locks</b> Freshly painted 2X tiny edge chips near bottom Slightly discoloured right edge Few light scuff marks bottom right corner 1X previous fitting mark near number 2 Top lock with deep scratch	<span style="color: green;">●</span> Good	<span style="color: green;">●</span> Good

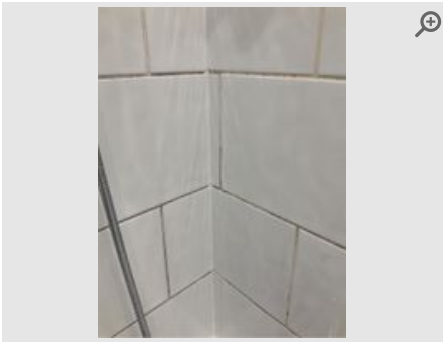
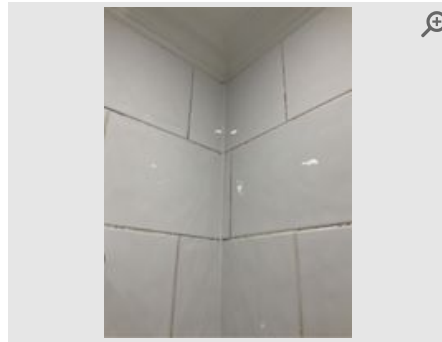
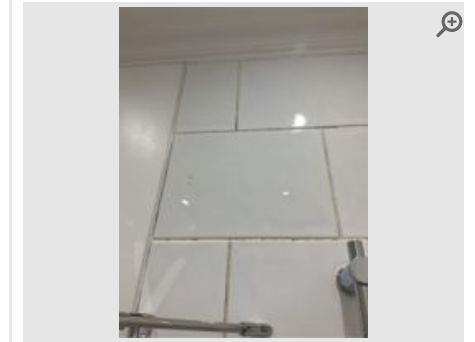
### Walls

2.8 <b>Walls</b>	<b>White tiled splashback</b> Hairline crack bottom left corner 4X filled holes high level Mildew stained grouting throughout Free of limescale	● Fair	● Good

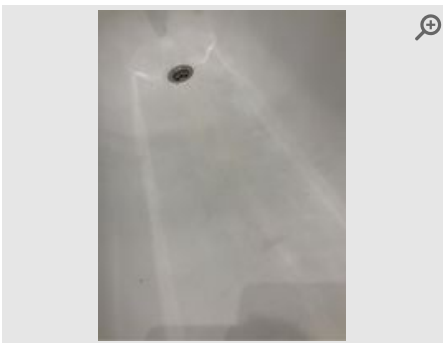
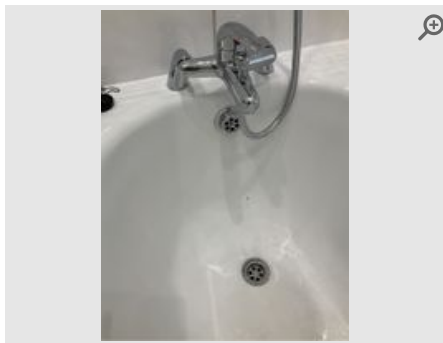
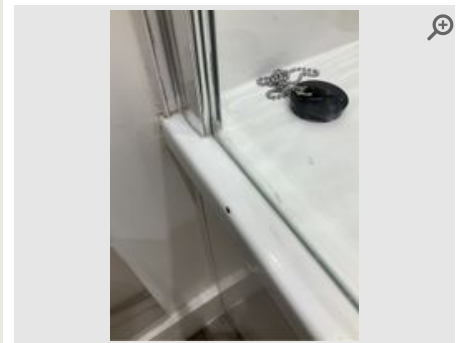
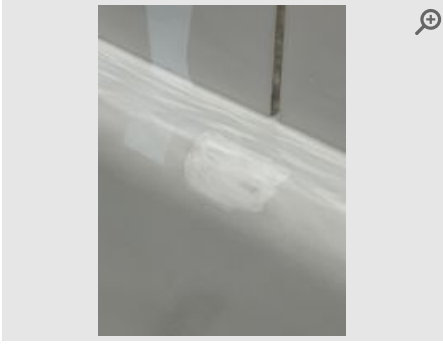
### Bath

2.12 <b>Bath</b>	<b>Standard white acrylic bath with white laminate side panel and chrome effect mixer tap, black plastic plug to chain</b> Scratches and discolouration to base Few chips under tap Chip to left edge exterior Painted over repair to opposite and right edge Shower working but unable to switch to tap Free of limescale	● Fair	● Good

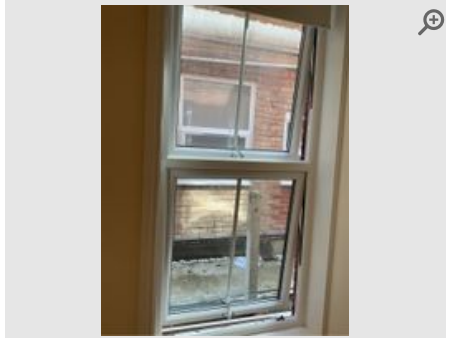
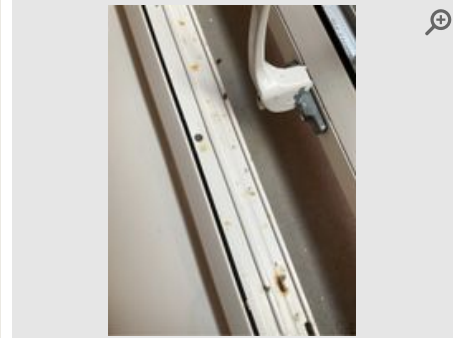
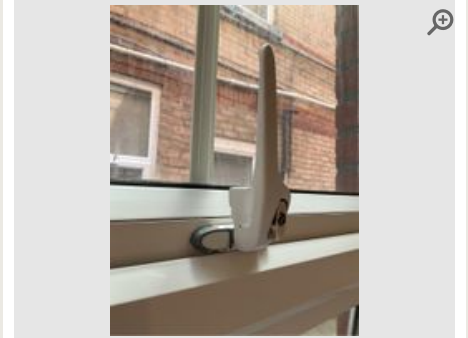
**Windows and Sills**

3.7 <b>Windows and Sills</b>	<b>White UPVC double glazed windows with white handles and white painted wooden frame</b> Freshly painted Tested and working Handles flaking Burn marks to bottom of frame interior Glazing clean inside	● Fair	● Good	  <a href="#">3 photos</a>

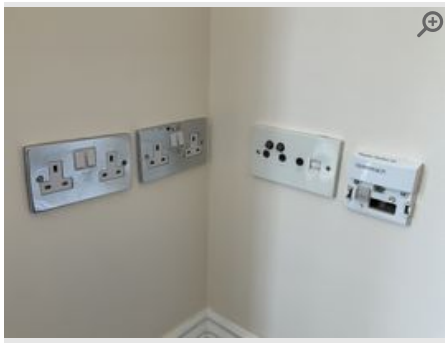
### Sockets & Switches

5.9 <b>Radiator</b>	<b>White panelled radiator(s)</b> Free of marks and scratches	● New Item	● Good	  N/A
5.10 <b>Sockets &amp; Switches</b>	All sockets/switches mixed metal/plastic. All fixings present & intact Lightly tarnished Telephone point cover missing	● Fair	● Good

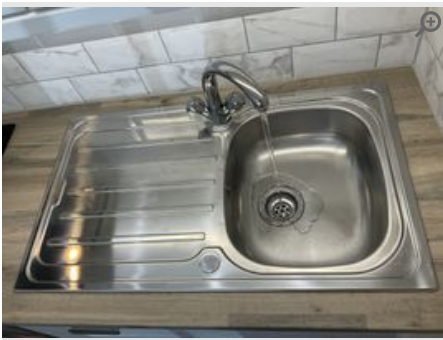
### Kitchen Sink

5.15 <b>Kitchen Sink</b>	<p><b>Stainless steel bowl and drainer with chrome effect mixer tap</b></p> <p>Tap tested and working Plug missing Free of limescale</p>	● New Item	● Good	📷 <a href="#">1 photo</a>
