Flat 2, 30 Walpole Road, Bournemouth,  
England, BH1 4HD

## This report contains

Property presented in very good order and has been newly renovated pretty much throughout.

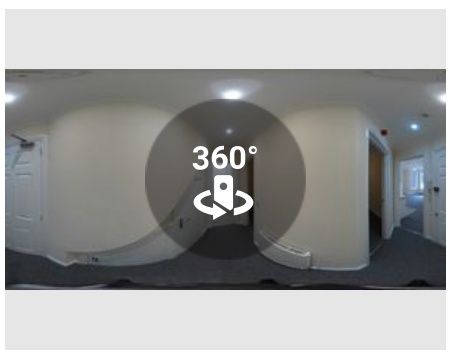
General Overview

1 Entrance/Hallway				
Item	Description	Condition	Cleanliness	Photos
1.1 <b>General Overview</b>	Clean & Tidy. Neutral smell/no odours evident Newly renovated	<span style="color: green;">●</span> Good	<span style="color: green;">●</span> Good

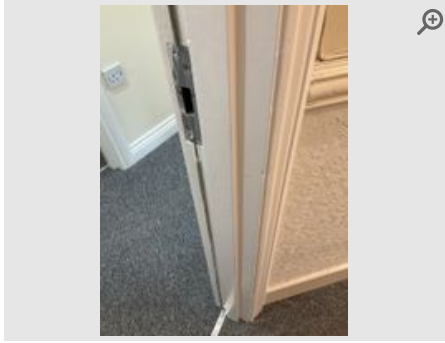
Door Frame

1.3 <b>Door Frame</b>	<b>White painted wooden frame</b> Freshly painted Painted over defects	<span style="color: green;">●</span> Good	<span style="color: green;">●</span> Good

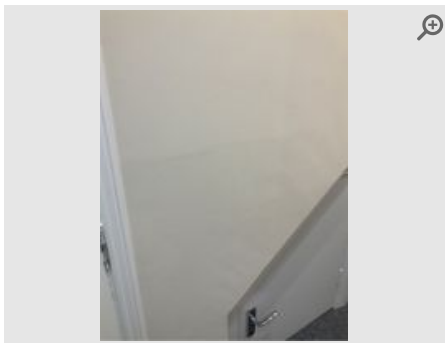
### Walls

1.8 <b>Walls</b>	<b>Plastered and painted cream</b> Freshly painted Free of scuffs and marks Painted over defects No wall fixings or filled holes	<span style="color: green;">●</span> Good	<span style="color: green;">●</span> Good

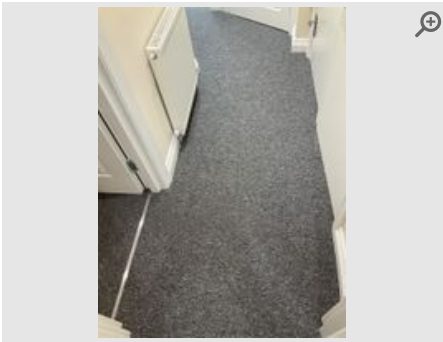
## Floor

1.11 <b>Floor</b>	<b>Grey fitted carpet</b> Newly fitted Free of marks and stains Free of dust and debris	<span style="color: green;">●</span> New Item	<span style="color: green;">●</span> Good

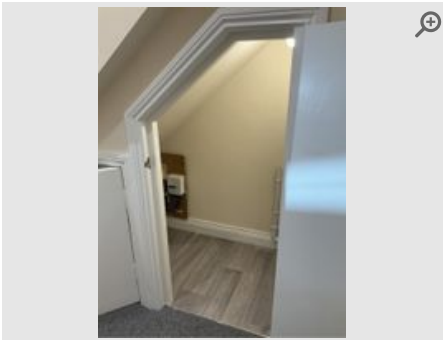
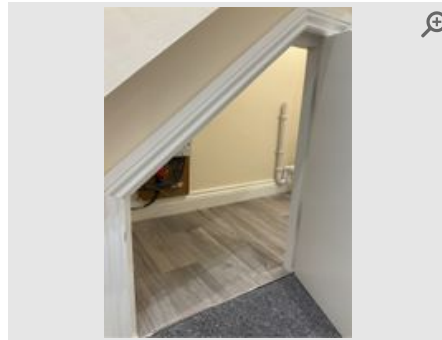
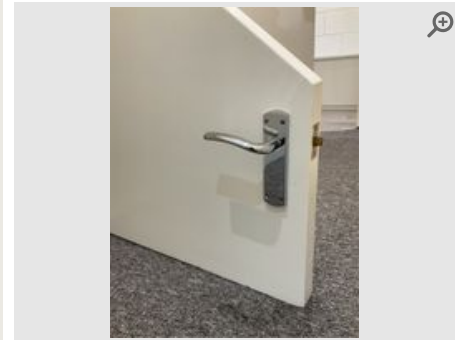
## Cupboards

Item	Description	Condition	Cleanliness	Photos
1.13 <b>Cupboards</b>	<p><b>Built-in cupboard with white painted wooden panelled doors and chrome effect handles, housing electric meter and fuse box</b></p> <p>Freshly painted</p> <p>Free of scuffs and marks</p> <p>Painted over defects</p> <p>Left door with light chips to base edge and 1X screw missing</p> <p>Free of items, dust and debris</p>	<p>● Good</p>	<p>● Good</p>	<p>

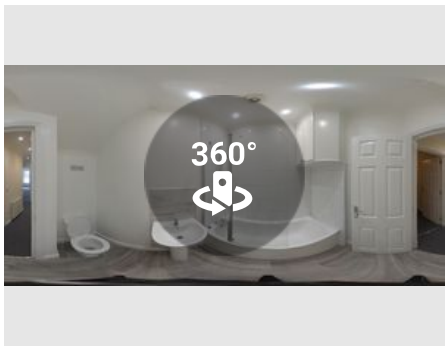
General Overview

Item	Description	Condition	Cleanliness	Photos
2.1 <b>General Overview</b>	Clean & Tidy. Neutral smell/no odours evident Mostly newly renovated	● Good	● Good

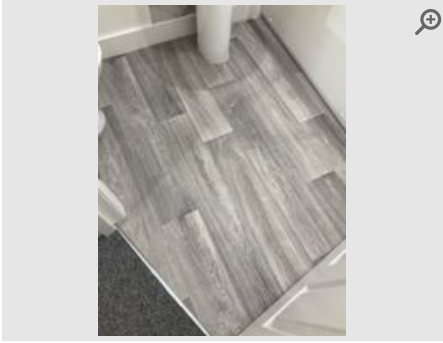
### Floor

<a href="#">1 photo</a>
2.10 <b>Floor</b>	<b>Grey wood effect lino flooring</b> Newly fitted Free of marks and stains Free of dust and debris	● New Item	● Good

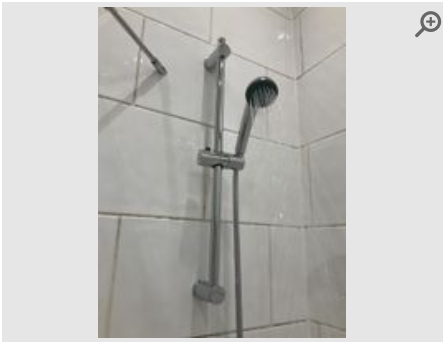
### Shower

Item	Description	Condition	Cleanliness	Photos
2.13 <b>Shower</b>	<b>Chrome effect head and hose to riser rail</b> Securely fitted and intact Free of limescale	● New Item	● Good

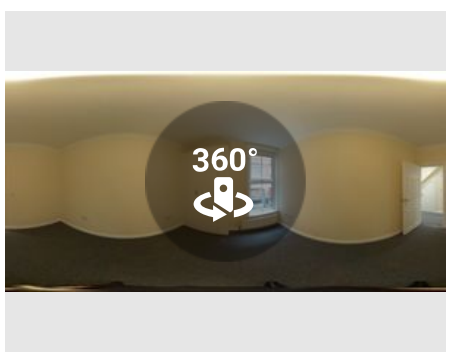
**General Overview**

Item	Description	Condition	Cleanliness	Photos
3.1 <b>General Overview</b>	Clean & Tidy. Neutral smell/no odours evident Newly renovated	● Good	● Good	  <a href="#">360° photo</a>

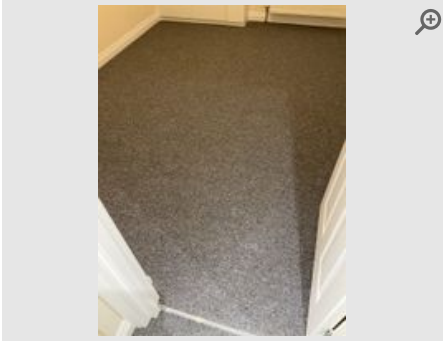
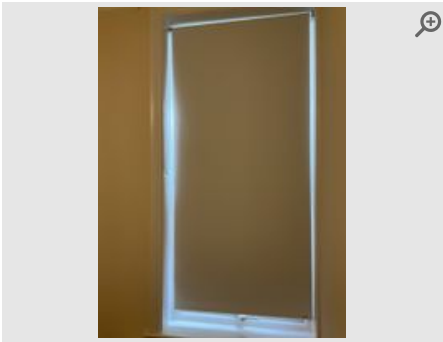
**Floor**

3.10 <b>Floor</b>	<b>Grey fitted carpet</b> Newly fitted Free of marks and stains Free of dust and debris	● New Item	● Good	  <a href="#">1 photo</a>
3.11 <b>Blinds</b>	<b>Cream roller blind</b> Tested and working Safety cleat fitted	● New Item	● Good	  <a href="#">1 photo</a>

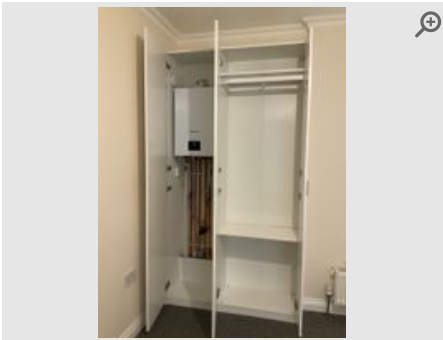
### Cupboards

Item	Description	Condition	Cleanliness	Photos
3.14 <b>Cupboards</b>	<b>White laminate built-in triple wardrobe with 2x shelves and hanging rail</b> Free of marks and scratches Free of items, dust and debris	● New Item	● Good	📷 <a href="#">1 photo</a>
3.15 <b>Boiler</b>	<b>White glowworm combination boiler</b> Power seen – not tested	● New Item	● Good	📷 <a href="#">1 photo</a>
3.16 <b>Carbon Monoxide Alarm</b>	Wall mounted. Test button/function working	● Good	● Good	📷 N/A

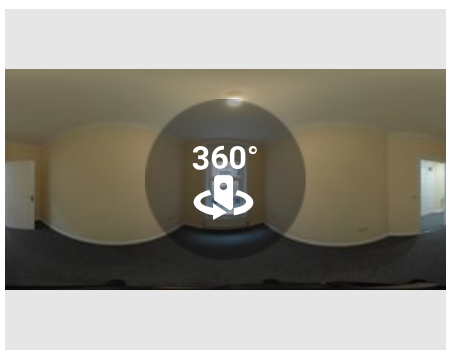
**General  
Overview**

Item	Description	Condition	Cleanliness	Photos
4.1 <b>General Overview</b>	Clean & Tidy. Neutral smell/no odours evident Newly renovated	● Good	● Good

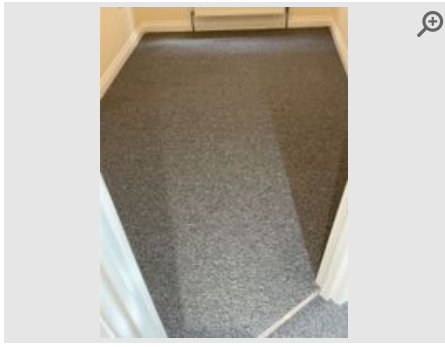
**Floor**

4.10 <b>Floor</b>	<b>Grey fitted carpet</b> Newly fitted Free of marks and stains Free of dust and debris	● New Item	● Good

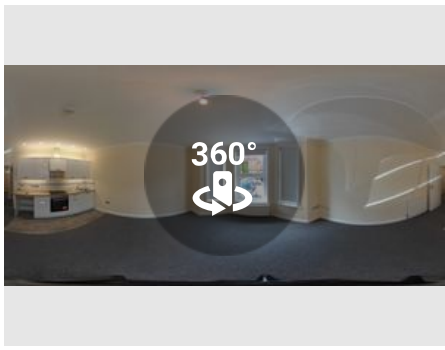
General Overview

Item	Description	Condition	Cleanliness	Photos
5.1 <b>General Overview</b>	Clean & Tidy. Neutral smell/no odours evident Newly renovated	● Good	● Good	  <a href="#">360° photo</a>

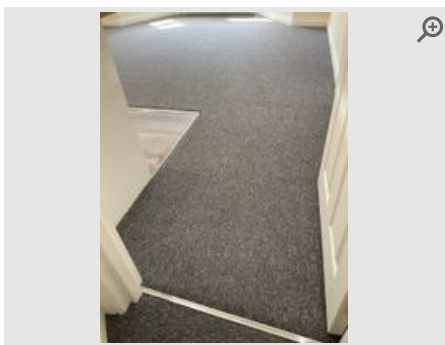
### Floor

5.11 <b>Floor</b>	<b>Grey fitted carpet</b> Newly fitted Free of marks and stains Free of dust and debris	● New Item	● Good

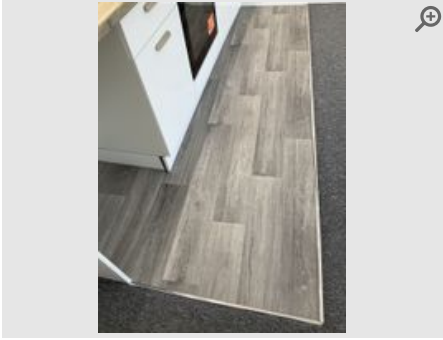
Provided by	<b>Inspector</b>
Captured (Certified by inspector)	<b>06/06/2026</b>
Added	<b>02/06/2026</b>
Reference	<b>5.12.1</b>

5.12 <b>Floor</b>	<b>Grey wood effect lino flooring</b> Newly fitted Free of marks and stains Free of dust and debris	● Good	● Good

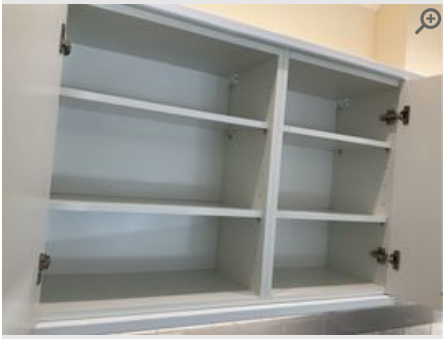
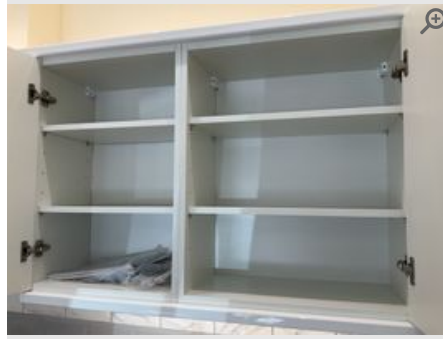
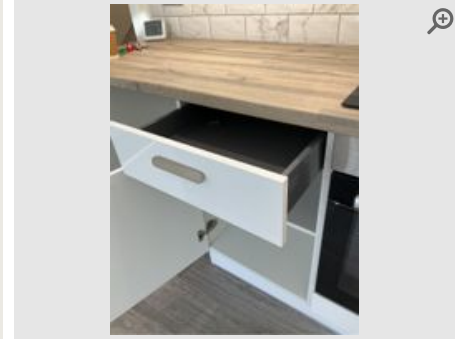
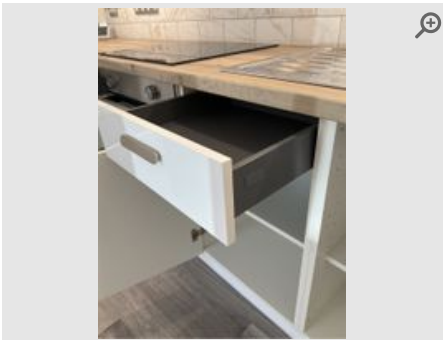
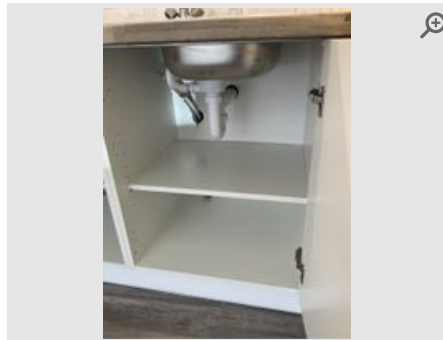
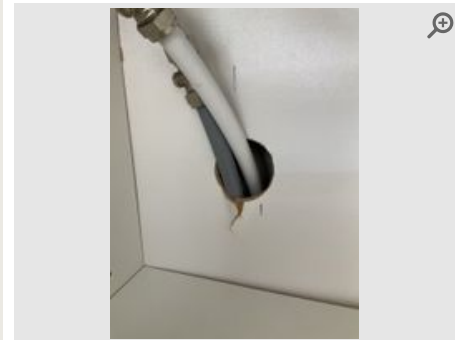
Item	Description	Condition	Cleanliness	Photos
5.13 <b>Kitchen Cupboards/Units</b>	<p><b>Range of white high gloss laminate units, listed from top left corner to right followed by base units;</b></p> <p>1x Double wall unit 1x Integrated cooker hood 1x Double wall unit 1x Single base unit with drawer 1x Single base unit with drawer 1x Single base unit under sink - light cracking to pipework surround Under unit lights both working Free of debris and residue to surfaces</p>	● New Item	● Good	📷 <a href="#">6 photos</a>

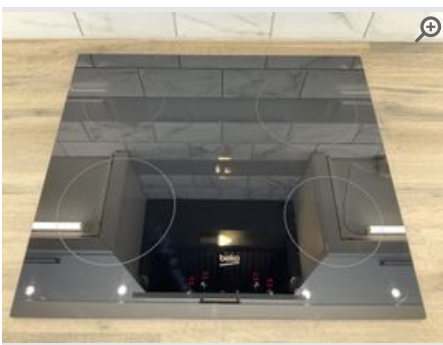
Provided by	<b>Inspector</b>
Captured (Certified by inspector)	<b>06/06/2026</b>
Added	<b>02/06/2026</b>
Reference	<b>5.16.1</b>

5.16 <b>Hob</b>	<p><b>Black ceramic hob (Beko)</b></p> <p>Intact Power seen Free of burnt on grease and residue to surfaces</p>	● New Item	● Good	📷 <a href="#">1 photo</a>

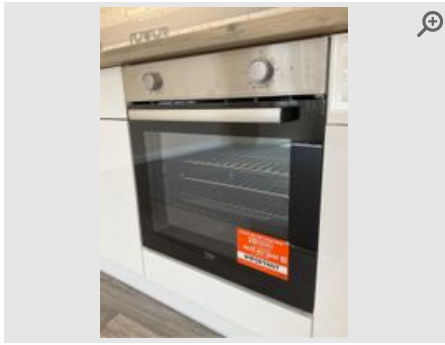
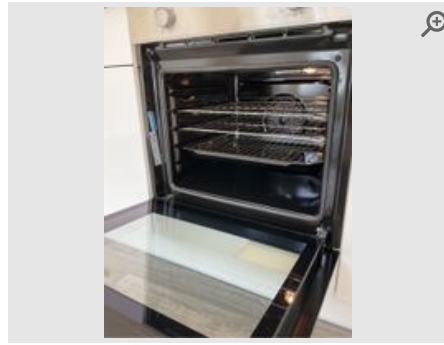
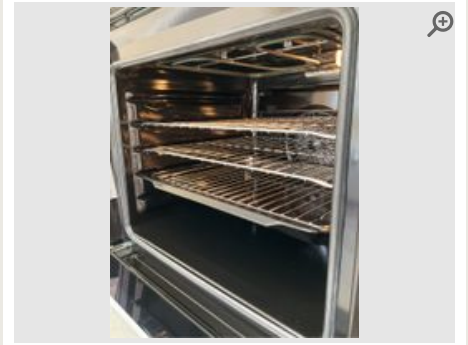
5.17 <b>Oven</b>	<p><b>Black and stainless steel integrated electric fan oven (Beko) with 2X shelves and grill pan</b></p> <p>Power seen – light working Free of burnt on grease and residue to surfaces</p>	● New Item	● Good	📷 <a href="#">3 photos</a>

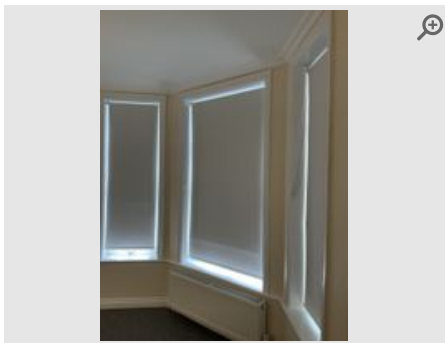
Provided by	<b>Inspector</b>
Captured (Certified by inspector)	<b>06/06/2026</b>
Added	<b>02/06/2026</b>
Reference	<b>5.19.1</b>

5.19 <b>Blinds</b>	<p><b>Cream roller blinds</b></p> <p>Tested and working Safety cleats fitted</p>	● New Item	● Good	📷 <a href="#">1 photo</a>
5.20 <b>Skirting Board</b>	<p><b>White painted wooden skirting</b></p> <p>Freshly painted Free of marks and scratches Stainless steel doorstop fitted Free of dust</p>	● Good	● Good	📷 N/A
